# **A First Information Report**

## **Current Scenario of Sikkim Glacial Lake Outburst Flood (GLOF)**

**Deepak Rawat**

**October 6, 2023**

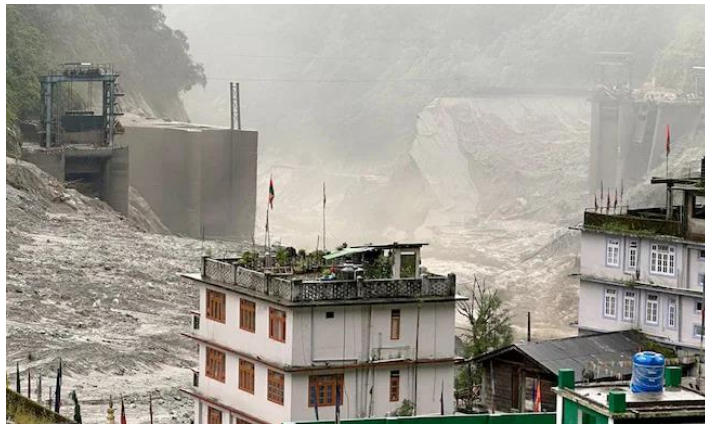
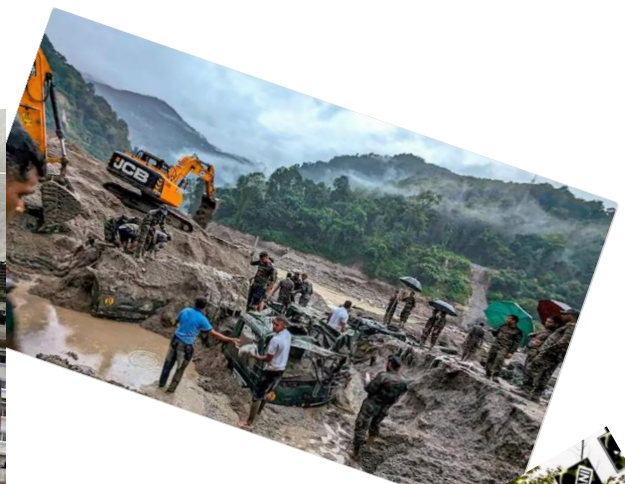
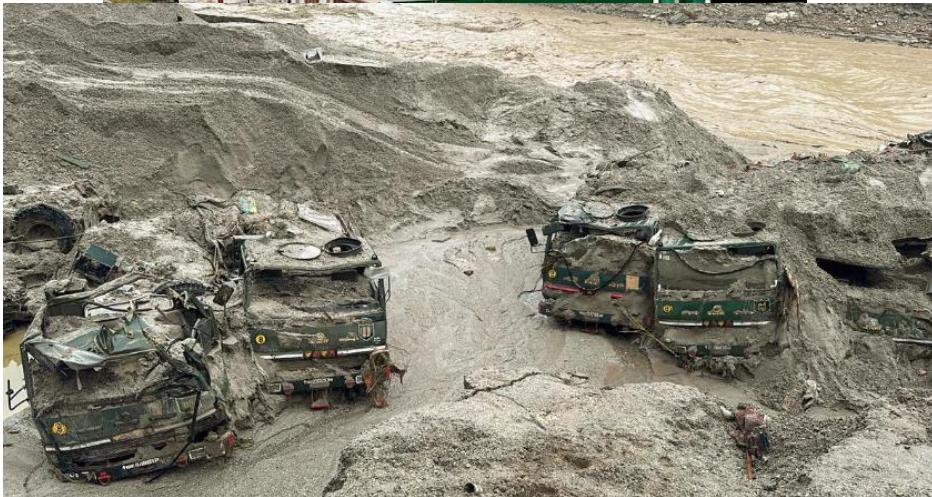
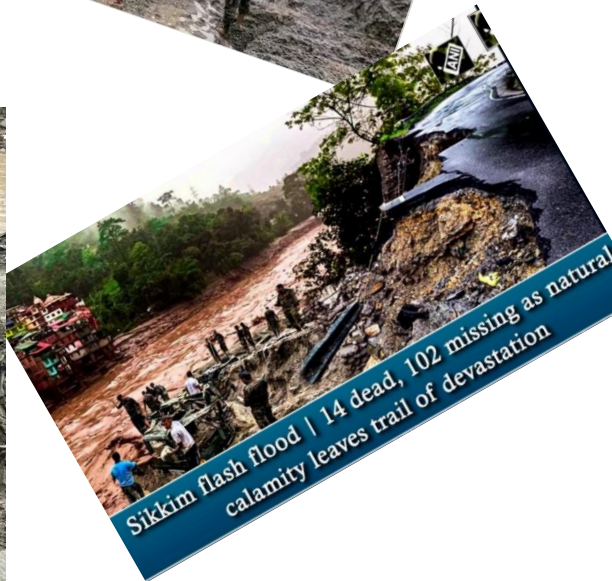
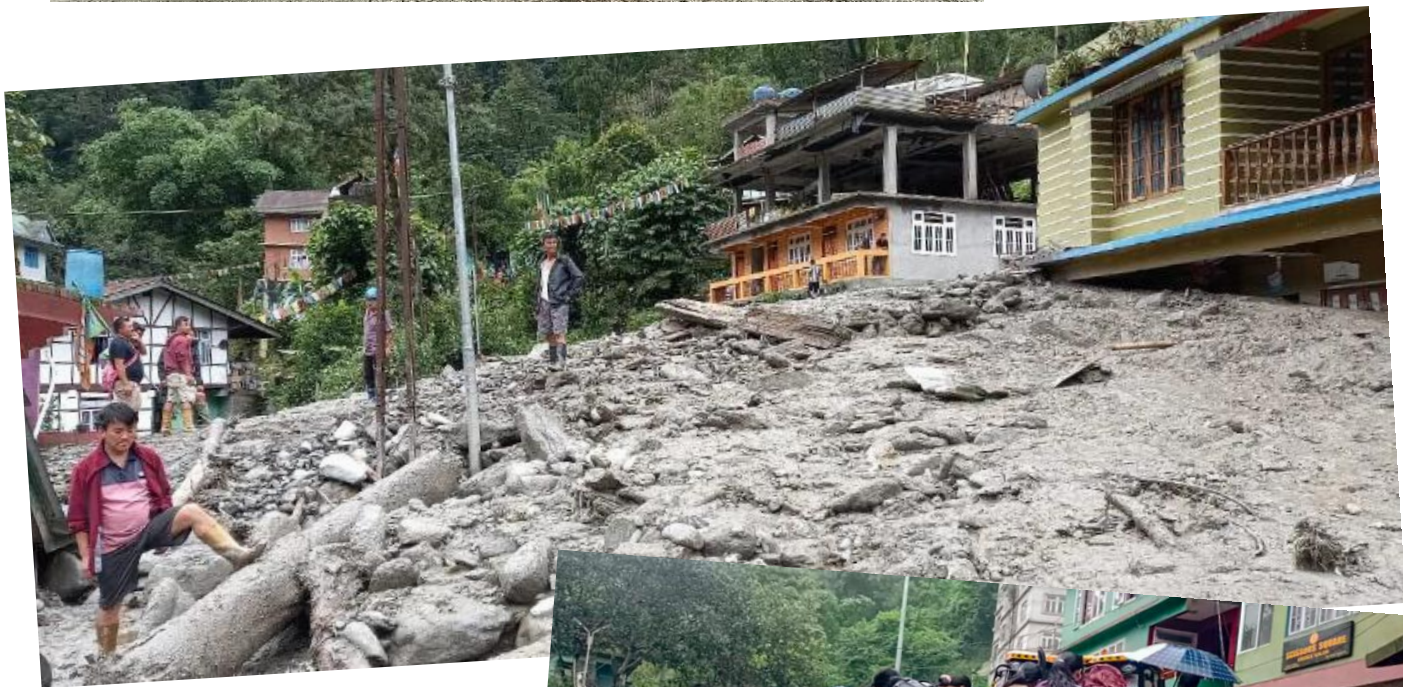
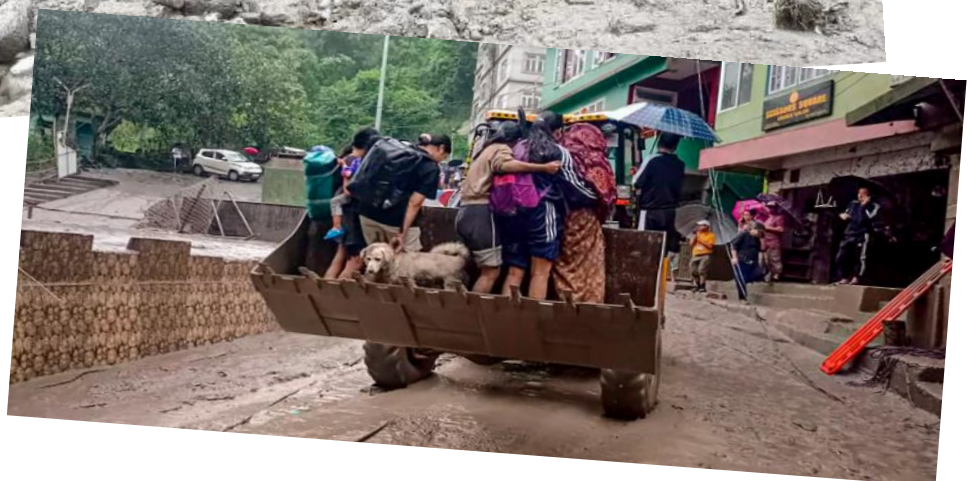
**Figure.1** South Lhonak Lake serves as the point of origin for the catastrophic flood event, and the subsequent course of the flood extends along the Teesta River and National Highway 10. This trajectory reveals the specific areas heavily impacted by the flash flood, resulting in property damage and significant consequences. The figure provides a clear depiction of the vulnerability of this valley, highlighting the presence of critical infrastructure, including schools, in the affected region.
